**Internal Leakage Study
Winyah Generating Station Unit #3**

Leif M. E. Svensen, P.E.
Santee Cooper
One Riverwood Drive
Moncks Corner, SC 29461
(843) 761-8000

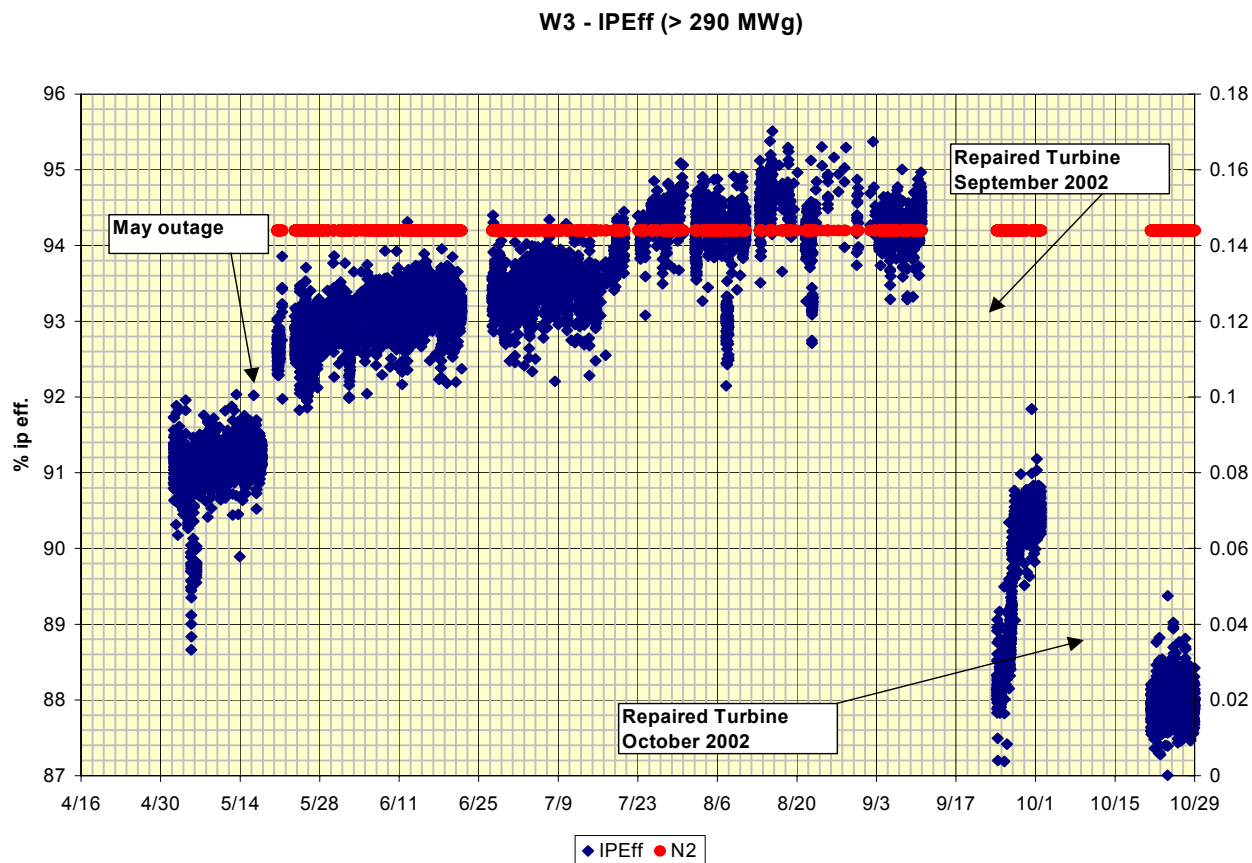
Figure 1

The increase in “apparent” IP turbine efficiency is the main reason that research of this event started. The “apparent” IP turbine efficiency is the measured efficiency without correcting for actual internal leakage rate of the turbine. As the internal leakage flow from the high pressure (HP) to IP turbine increases, the colder steam entering the IP bowl from the first stage of the HP turbine reduces the crossover temperature. The reduction in crossover temperature causes a change in the enthalpy thus causing the IP turbine efficiency to “appear” to increase. The other reason for this “apparent” increase is that the inlet conditions do not reflect the change as they are before the IP bowl. Therefore, by not changing the bowl conditions to account for the current internal leakage rate as a percent of hot reheat flow, the IP section efficiency rises. We continued to track this “apparent” IP efficiency change throughout June and July. During this period, the “apparent” IP efficiency gradually increased (See figure 1).
