Sask Power ER Successes

August 2010

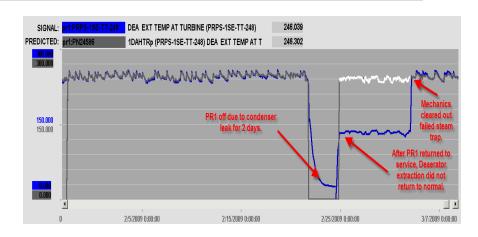
The PR1 Deaerator Story

- After unit returned to service, the Deaerator was not performing as before
- Extraction steam temp & pressure dropped considerably
- No Operator concern identified
- Found steam trap on extraction valve not fully opened
- Ultimately found extraction steam trap was plugged

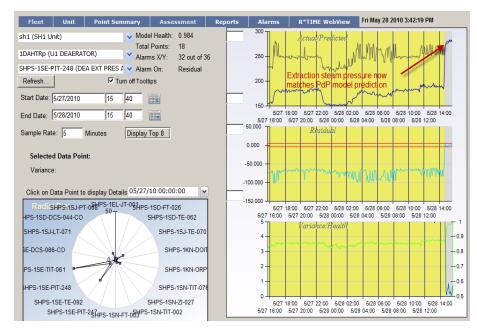
The SH1 Deaerator Story -2

- After start-up, problems with condenser backpressure
- Performed testing, closed extraction steam valve
- Never re-energized control drive for valve
- No indication of problem on Operator DCS screens
- No serious problem, but could have affected heat rate

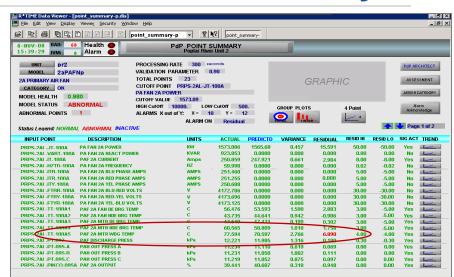
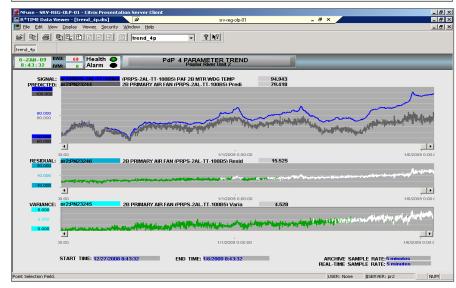
The #2A & #2B Primary Air Fan Motor Story

- After model retraining, identified increasing winding temps
- Indications were of a motor cooling problem
- Found plugged filters
- No indication of problem on Operator DCS screens
- Could have led to cycle inefficiencies, higher load draw, or motor failure

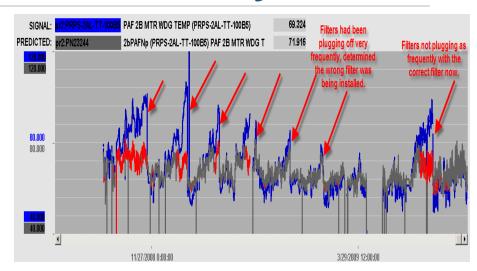
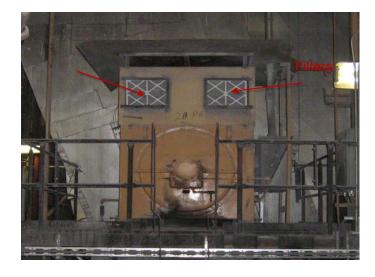
The #2B Primary Air Fan Motor Story

- PdP identified cyclic winding temp conditions (correlated with plugged air filters)
- 2A was responding different
- Inspection of 2B found wrong size (finer) filter
- Could have led to cycle inefficiencies, higher load draw, or motor failure

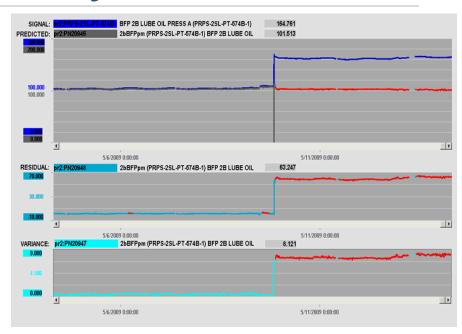
The #2B BFP Oil Pump Story

- PdP identified lube oil pressure change, much higher than should be
- Found Aux Oil Pump was continually running in "Auto" (normally "off")
- No DCS alert to Operators
- If left on continuously, could have led to Aux Oil Pump failure, or BFP bearing problems

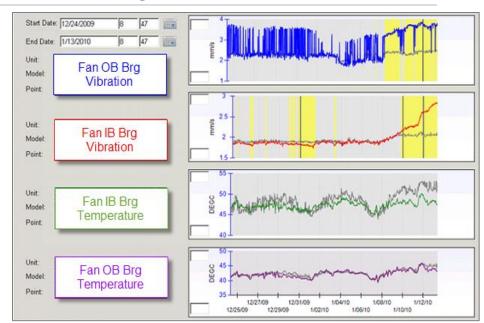
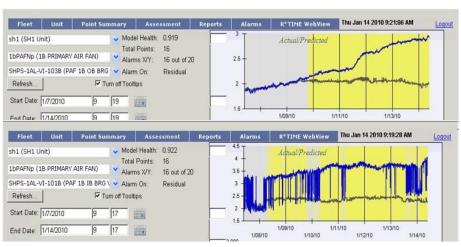
The #1B Primary Air Fan Story

- PdP identified very early indication of a InBd Bearing vibration concern
- The PdP identified step change of OtBd Bearing vibration
- Then PdP re-alerted on the InBd Bearing
- Vibration study did not identify anything significant
- 4 days later, fan bearing failed
- Potential avoided costs >\$100K

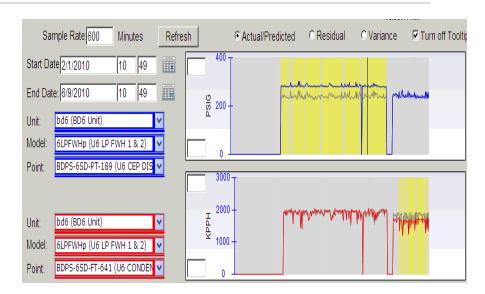
Also, #6 Condensate Extraction Pump Story

- PdP identified decreasing
 Feedwater Htr low control valve position at full load
- Reviewed drain line configurations
- Determined probable problem with alternate drain line
- Drain inspected and adjustments made to the heater drain valve configuration, no further control valve problem
