PPC (Plant Process Computer) Replacement Project for TEPCO

Summary and Lessons Learned

Masaichi Kitajima Hidefumi Naito Tokyo Electric Power Services Co.,Itd

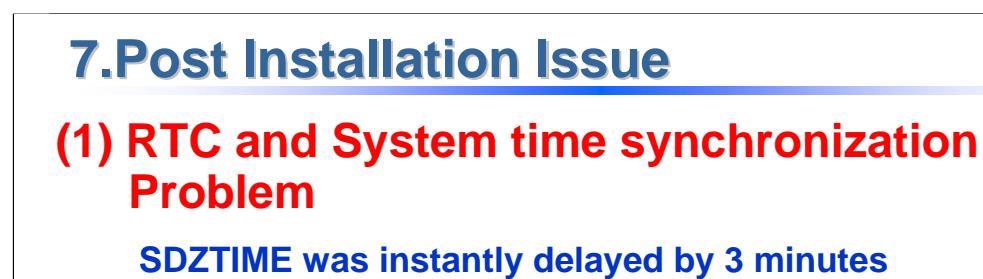
(2) Firmware of Raid controller Problem

Server restarted frequently caused by a bug of Raid controller

(3) Automatic Fail Over Problem

Server failed in automatic fail over when critical process stopped

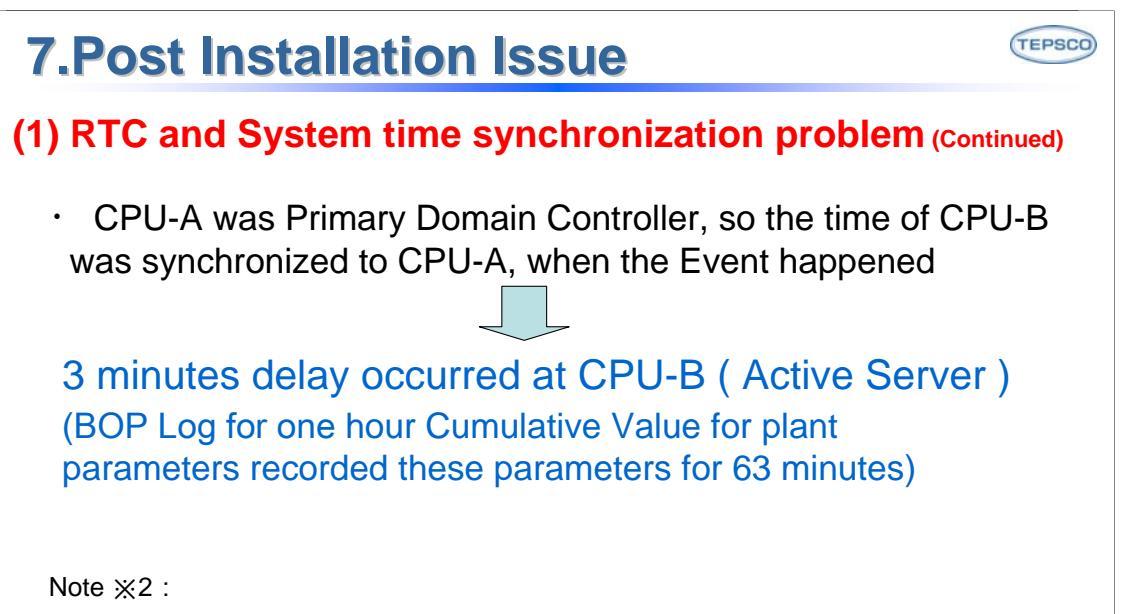
- Both CPU-A and CPU-B had been operating more than 3 months, and RTC of CPU-A was getting delayed and the delay was being accumulated from start-up (About 3 min delayed at that time)
- · CPU-A was shutdown for some reasons.
- At that time, the time of RTC was not equalized to system time because of Bug in w32time. *1
- After that, CPU-A made to restart-up, when system time of CPU-A was matched to the delayed RTC time and did not synchronize since then. *2

According to w32Time configuration, system time of CPU-A was designed to be synchronized to time keeper when time difference is less than the duration of 1 min, in this case synchronization was not made due to 3 min delayed

- 1) Update of the latest "w32Time.dll" to synchronize to RTC time to System time when server is shut down
- 2) Checking support site of Software vendor (Microsoft) frequently and available update should be evaluated whether to install that
