Wind Turbine Condition Monitoring at Edison Mission Energy

August 2010

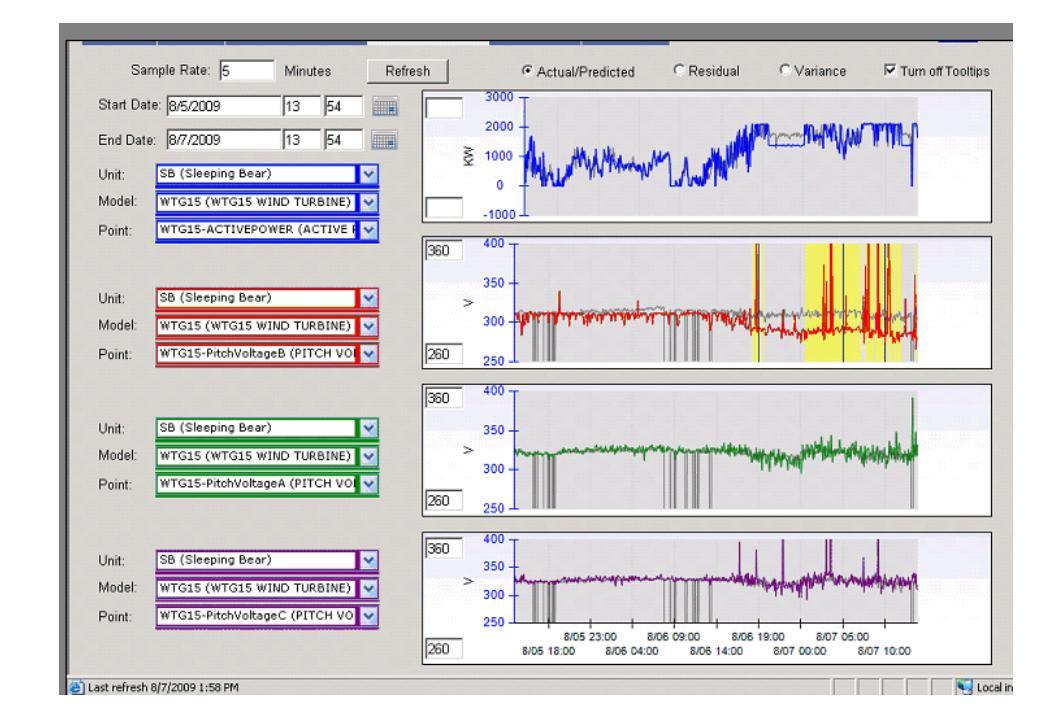
Blade Pitch Voltage Control Catch -3

- PdP identified 'A' Pitch Voltage changes
- Found blade pitch drive to have problem of irregular voltage control
- Verified OEM part problem
- Critical element for blade
 braking
