Scientech Stresswave SRV Leak Detection

Scientech Symposium 2015

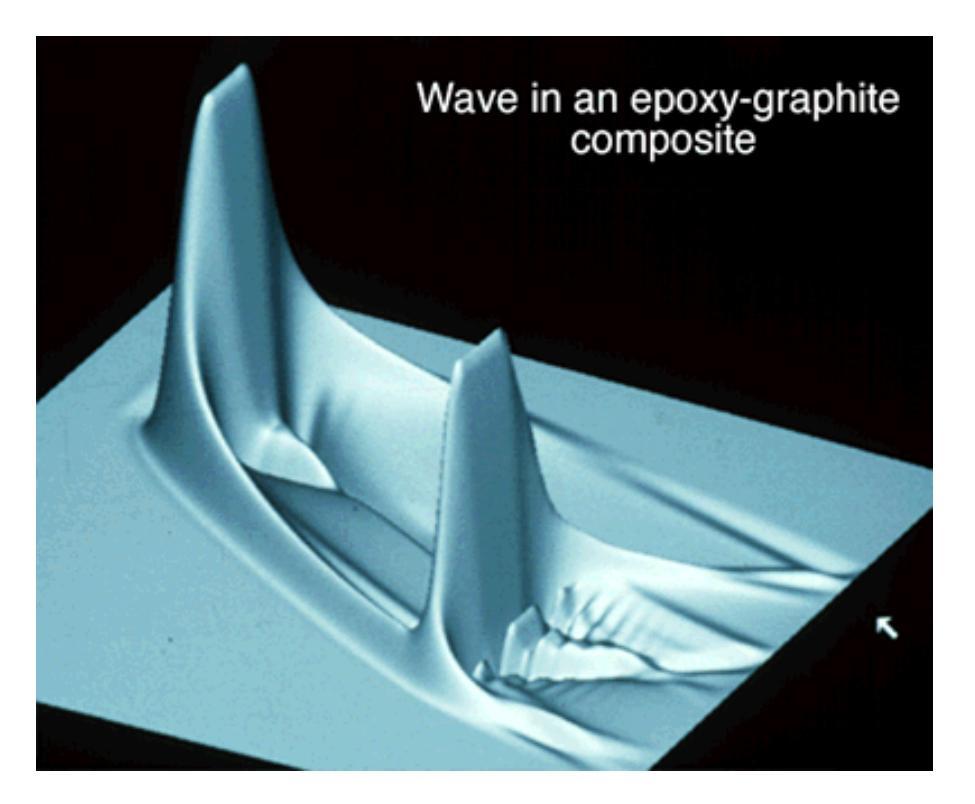
What Are Stresswaves?

Stresswaves are ultrasonic acoustic energy impulses (~40kHz) that radiate through solid, liquid and gas in all directions.

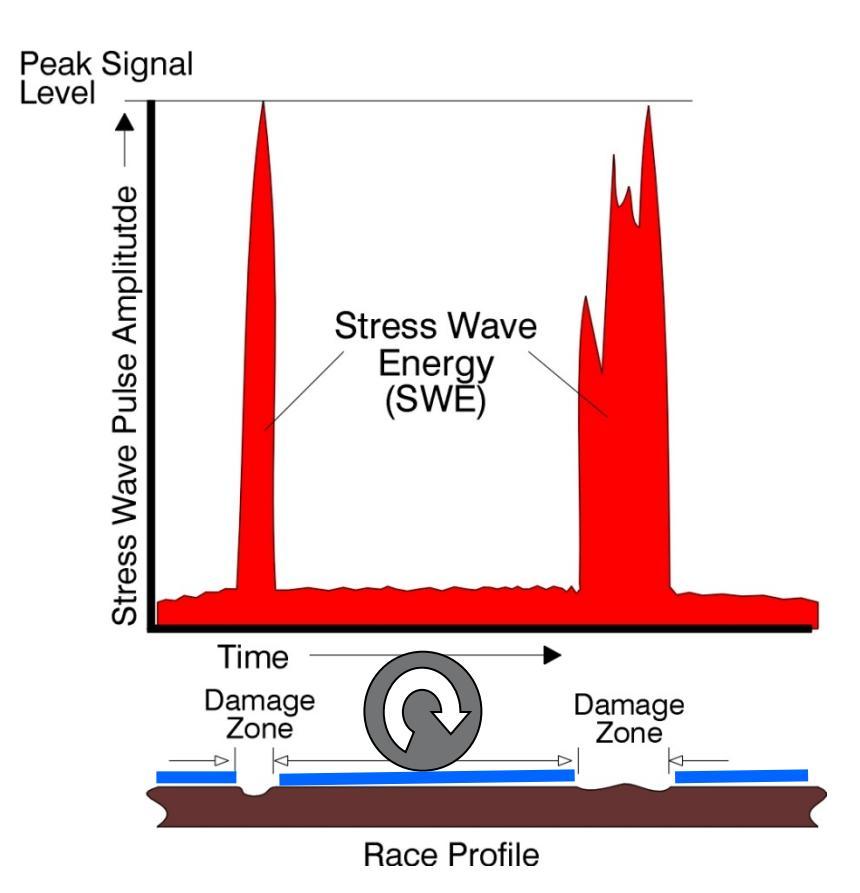
- SWE = Stress Wave Energy
- A unit of measure based on the energy contained within the raw sensor signal
- Increases in orders of magnitude as stress and friction increase.

- Piezoelectric accelerometer
- Designed specifically to utilize the natural resonant frequency of the piezoelectric crystal element
- The sensor incorporates an internal filter to reduce low frequency noise
- INTRINSIC SAFETY:
 - Class I, Division 1, Groups A, B, C & D
- Process Temperature -50°C to 120°C
- Radiation hardening: manufacturer is recommending 100 Mrad test

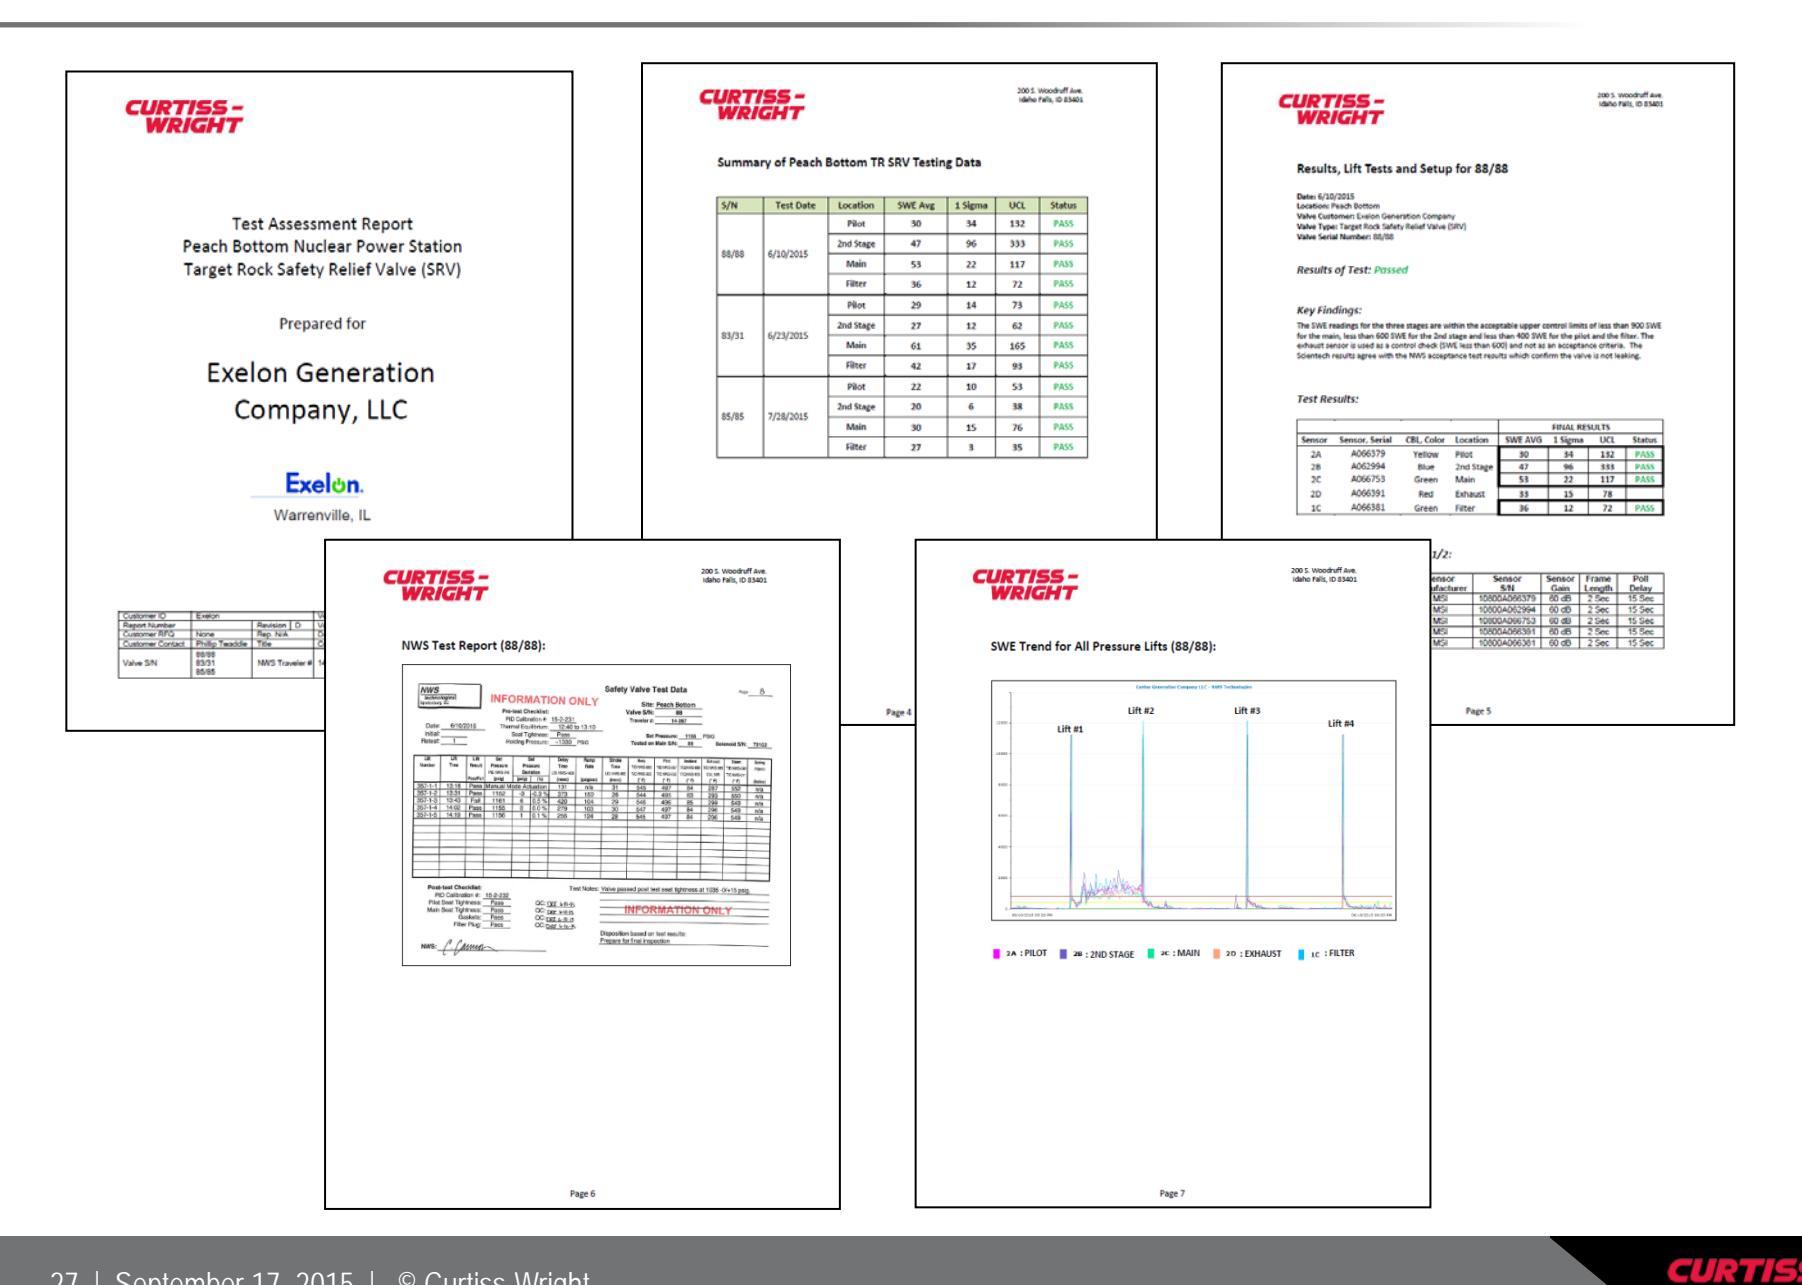
Scientech Report

- SWE = Stresswave Energy
 - Total stress energy contained within sensor signal
- Sigma = Standard Deviation
 - Amount of variation from the average
- UCL = Upper Control Limit
 - Statistical distribution limit of the SWE level of the tested valve

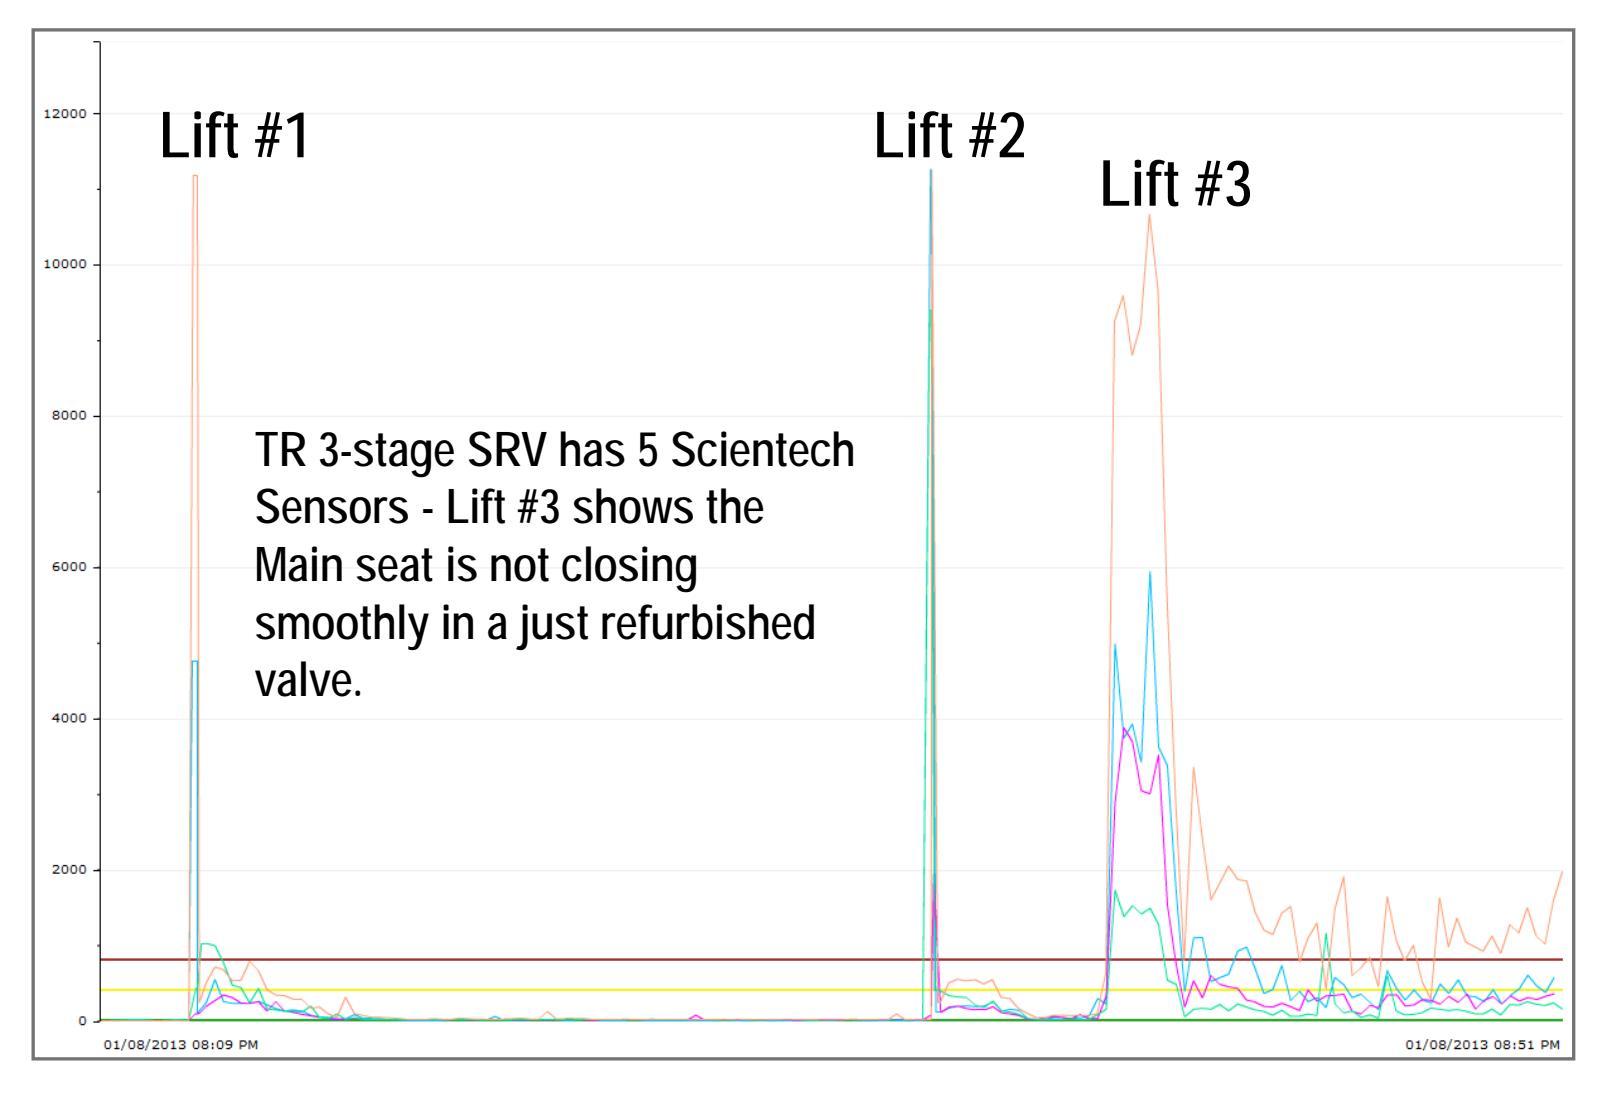
NWS Valve Maintenance – TR SRV

First Two Lifts were OK, and Lift #3 Failed Cold Bar Testing

- Two automatic lifts were performed and leakage was detected at ~750psig
- The valve was fully disassembled for repair
- The main piston rings were found to have scoring marks and were replaced
- The main seat and disk were lapped again and the SRV was placed on the steam test cell for As-Left Certification
